**Copper in Rock Chip Samples**

<b>PANORO APURIMAC S.A.</b>					
<b>Copper in Rock Chip Samples</b>					
Project: <b>Cotabambas Project</b>					
Drawing: edego	Revised: L.V	Approved: L.V	Area: Exploration	Lamine	
Date: July-2017	Format: A1	Scale: 1:5,500	File Name: G:\PROYECTOS\APURIMAC\GENERAL\Mapas\proyecto_Panoro_Cotabambas\cotabambas_01.pdf	2	
	Version: 01	Location: Antilla-Apurimac

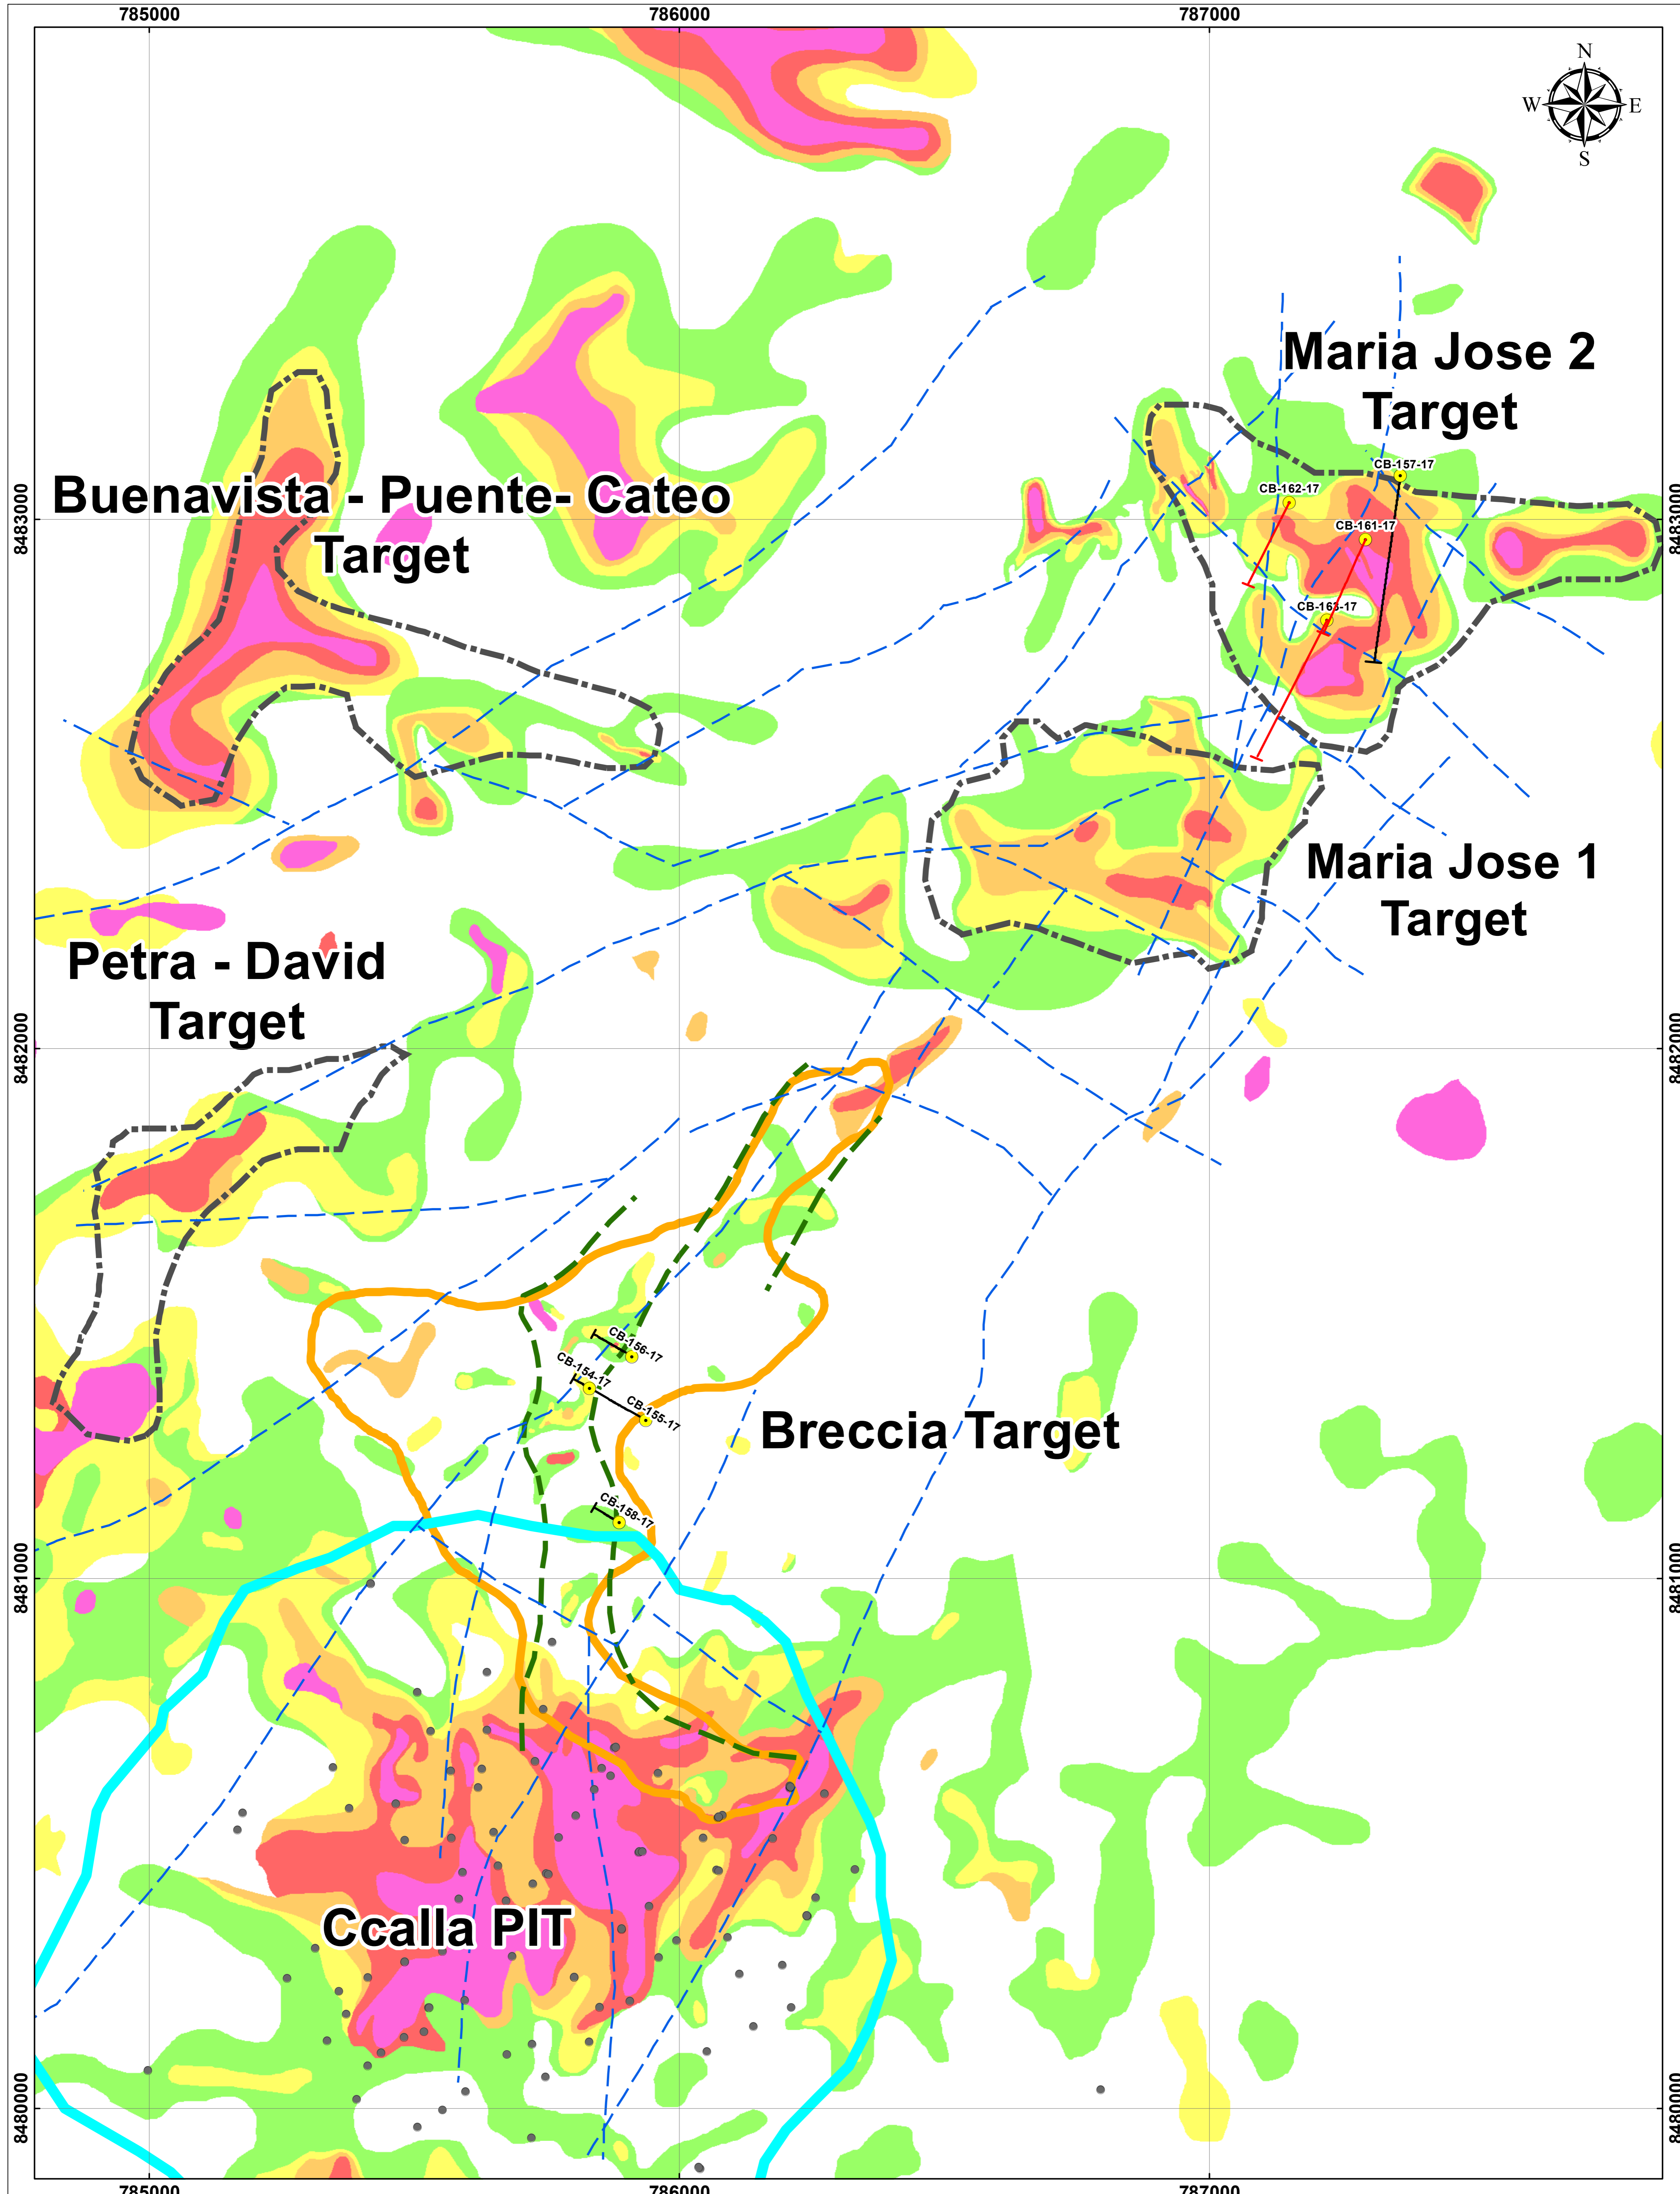
<b>Simbology</b>		<b>Copper Distribution</b>		<b>Mineralogy/Alteration</b>	
	Faulting		100-200		Pervasive Argilization Influence
	PEA-Ccalla Pit		200-500		Gold-Structural control
			500-1000		Target
			1000-2000		Executed Drill Hole
			>2000		Old Hole
